**PHASE II ENVIRONMENTAL SITE ASSESSMENT
VACANT PARCELS (361-371)**

**CITY OF HAGERSTOWN
EPA BROWNFIELD PILOT PROJECT**

URS

JANUARY 2005

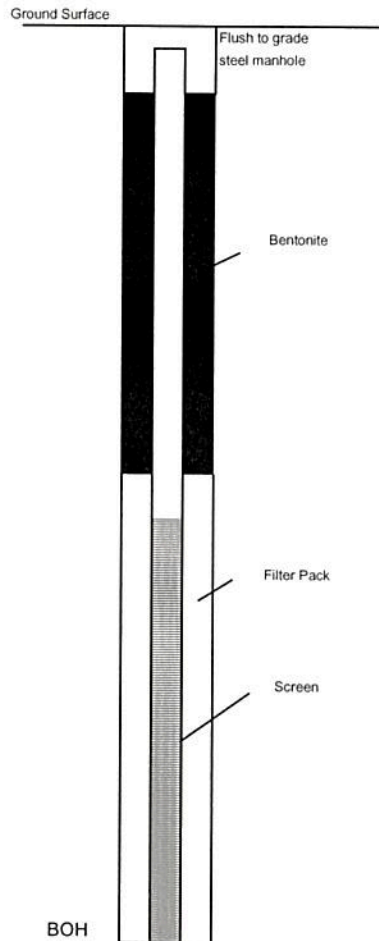
AS BUILT MONITORING WELL RECORD

HOLE NUMBER: VMW-1	LOCATION: 367 E. Franklin Street, Hagerstown, Maryland	DRILLER: Connelly and Associates
PROJECT: Vacant Lot Phase II	ELEVATIONS (FT MSL)	Depth to GW (FT): 40'
DATE WELL COMPLETED: September 10, 2003	SURFACE:	NA
DATE DEVELOPMENT COMP: September 11, 2003	TOP OF PVC CASING:	NA
INSPECTOR	TOP OF OUTER CASING:	NA
		DRILLING METHOD: Hollow stem auger with air hammer
		DEVELOPMENT METHOD:

COORDINATES (Approximate): NORTH: NA
EAST: NA

STICK UP TO TOP OF PROTECT CASING: NA
STICK UP TO TOP OF RISER PIPE: NA

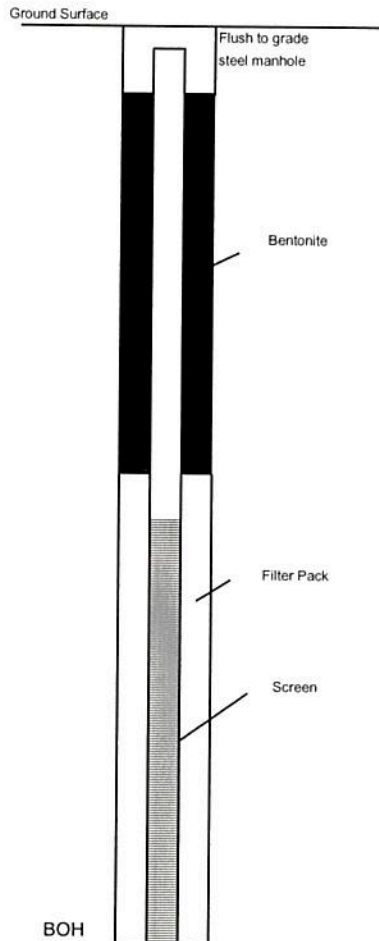
AS BUILT MONITORING WELL RECORD

HOLE NUMBER: VMW-1	LOCATION: 367 E. Franklin Street, Hagerstown, Maryland	DRILLER: Connelly and Associates
PROJECT: Vacant Lot Phase II	ELEVATIONS (FT MSL)	Depth to GW (FT): 14.5'
DATE WELL COMPLETED: September 11, 2003	SURFACE:	NA
DATE DEVELOPMENT COMP: September 12, 2003	TOP OF PVC CASING:	NA
INSPECTOR	TOP OF OUTER CASING:	NA
		DRILLING METHOD: Hollow stem auger with air hammer
		DEVELOPMENT METHOD:

COORDINATES (Approximate): NORTH: NA
EAST: NA
STICK UP TO TOP OF PROTECT CASING: NA
STICK UP TO TOP OF RISER PIPE: NA

I.D. OF PROTECTIVE CASING: Flush to grade steel manhole
TYPE OF PROTECTIVE CASING: 2"
I.D. OF RISER PIPE: Sch. 40 PVC
TYPE OF RISER PIPE: NA
TYPE OF GROUT: NA
